**DEPARTMENT OF TRANSPORTATION****DIVISION OF ENGINEERING SERVICES**

Quality Assurance and Source Inspection

Contract #: 04-0120F4Cty: SF/ALA Rte: 80 PM: 13.2/13.9File #: 1.28**WELDING INSPECTION REPORT****Resident Engineer:**Siegenthaler, Peter**Address:** 333 Burma Road**City:** Oakland, CA 94607**Report No:** WIR-017530**Date Inspected:** 20-Oct-2010**Project Name:** SAS Superstructure**OSM Arrival Time:** 630**Prime Contractor:** American Bridge/Fluor Enterprises, a JV**OSM Departure Time:** 1500**Contractor:** American Bridge/Fluor Enterprises, a JV**Location:** Job Site**CWI Name:** See below**CWI Present:** Yes No**Inspected CWI report:** Yes No N/A**Rod Oven in Use:** Yes No N/A**Electrode to specification:** Yes No N/A**Weld Procedures Followed:** Yes No N/A**Qualified Welders:** Yes No N/A**Verified Joint Fit-up:** Yes No N/A**Approved Drawings:** Yes No N/A**Approved WPS:** Yes No N/A**Delayed / Cancelled:** Yes No N/A**Bridge No:** 34-0006**Component:** SAS OBG**Summary of Items Observed:**

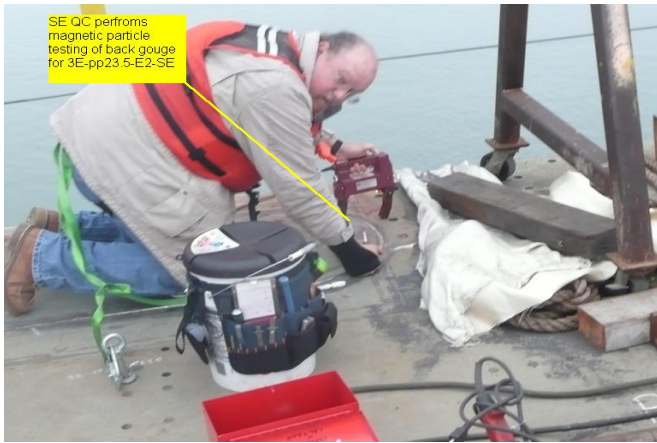
blankets to side of the stiffener opposite the welding. The QA Inspector noted the material must maintain the minimum required preheat of 200°F through out the duration of welding. The QA Inspector randomly observed the ABF welder preheat the area to approximately 250°F prior to performing any SMAW. After the minimum required preheat had been achieved, the QA Inspector randomly observed the ABF welder begin the SMAW root pass. The QA Inspector noted the SE QC Inspector John Pagliero was on site to monitor and record the in process production welding at the above identified location. The QA Inspector randomly observed the SMAW parameters to be approximately 135 Amps with 1/8" E9018 low hydrogen electrodes. The QA Inspector randomly observed the in process welding parameters and dimensional tolerances appeared to be in general compliance with the approved welding procedure identified as ABF-WPS-D1.5-1012-3. The QA Inspector noted the ABF welder did not complete the SMAW on the QA Inspectors shift.
